City of Miami Cemetery  
Marker and Monument Condition Survey Report  
Conducted Winter/Spring 2020

*Prepared for*  
**Dade Heritage Trust**  
190 Southeast 12 Terrace  
Miami, FL 33131

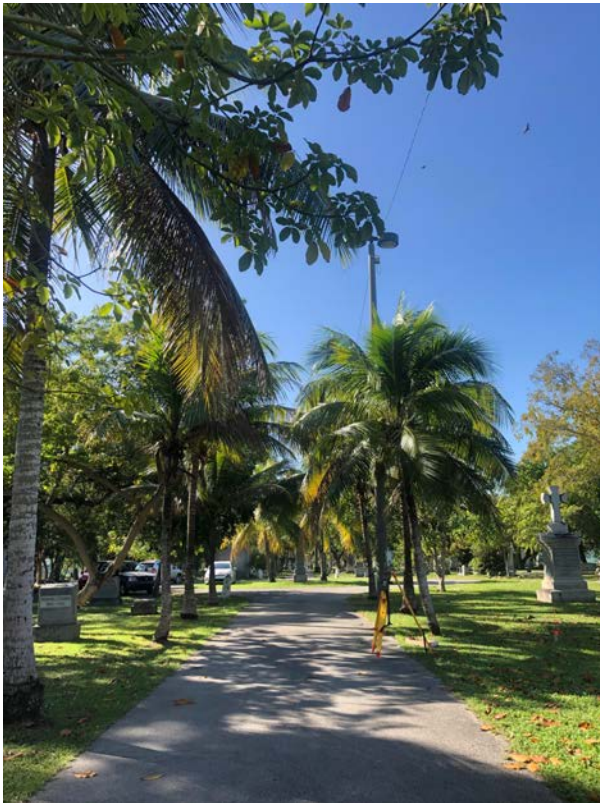
There is one public two-way road that bisects the City of Miami Cemetery. There are two traffic circles that include grave markers and monuments.

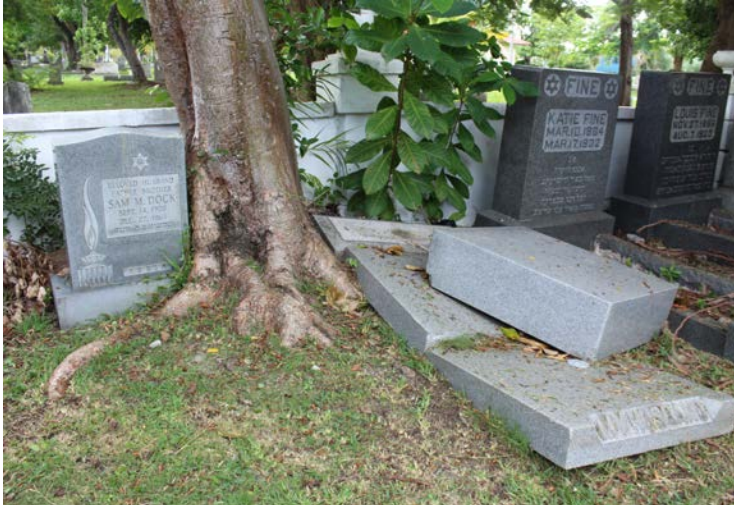
*Although vegetation generally does not have a negative impact in the cemetery, there are certain location such as Jewish section where the roots of large trees have caused the collapse of markers or threaten their stability.*

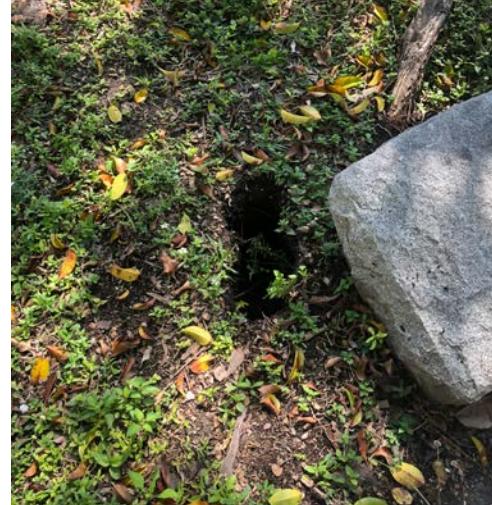
The ground in the southeastern portion of the cemetery was found to be soft and unstable. A surveyor's foot punched into the ground near a marker.

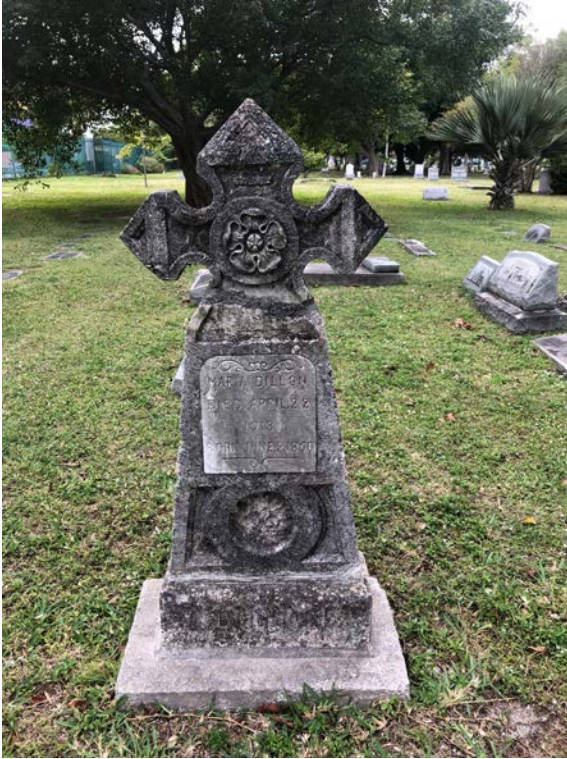
One of the five (5) coral stone (oolitic limestone) markers with a marble plaque. This marker was considered to be in fair condition, but 3 of the other markers require treatment.

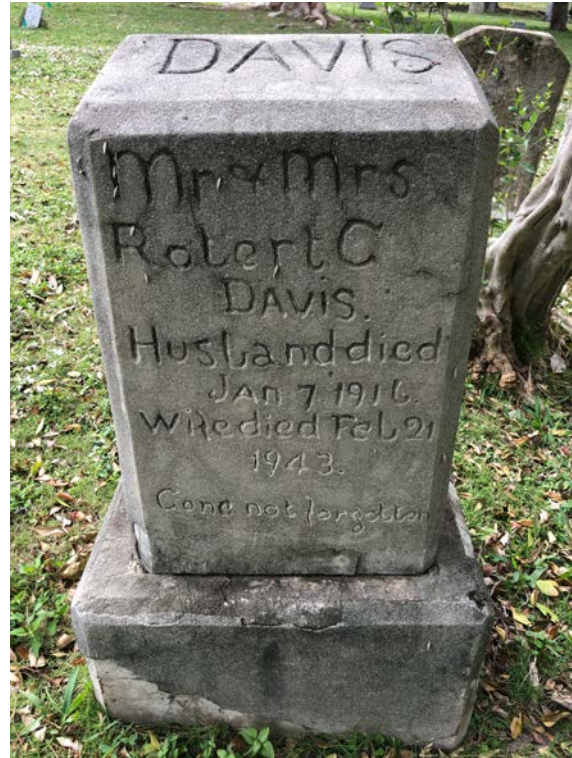
A hand carved marker found in the African American section of the cemetery. There are less than 20 of these hand carved markers.

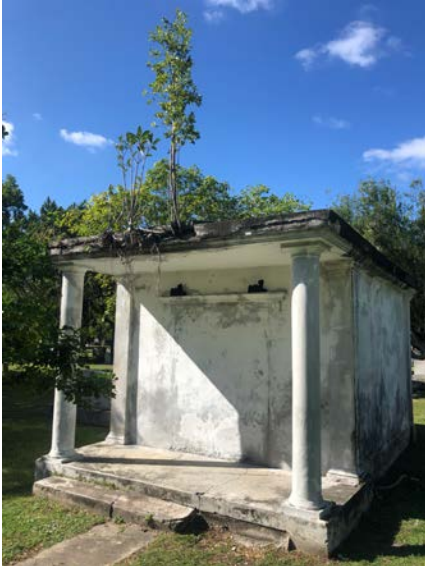
*Overall image of the only mausoleum to score a "poor" condition rating. Structural cracks and vegetation put this structure at high risk of continued deterioration and intervention should be prioritized.*

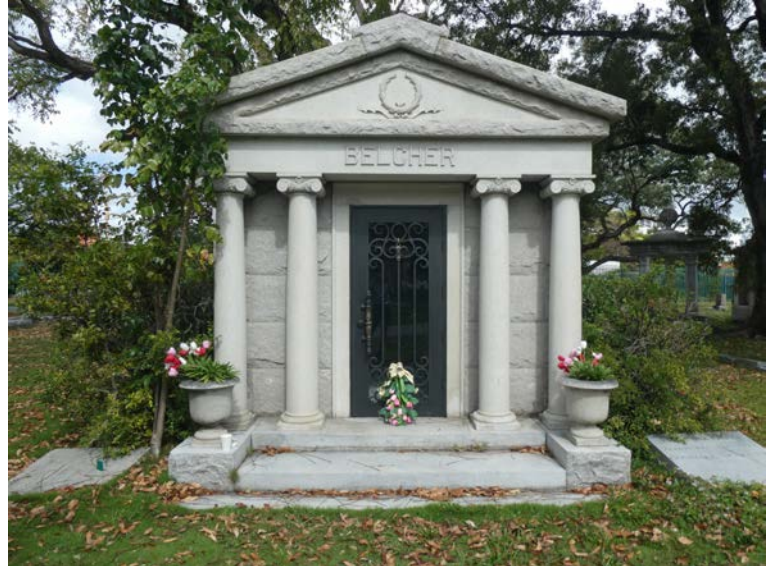
*The Belcher mausoleum is that largest mausoleum in the cemetery and is in impeccable condition. It retains a majority, if not all, of its original elements.*

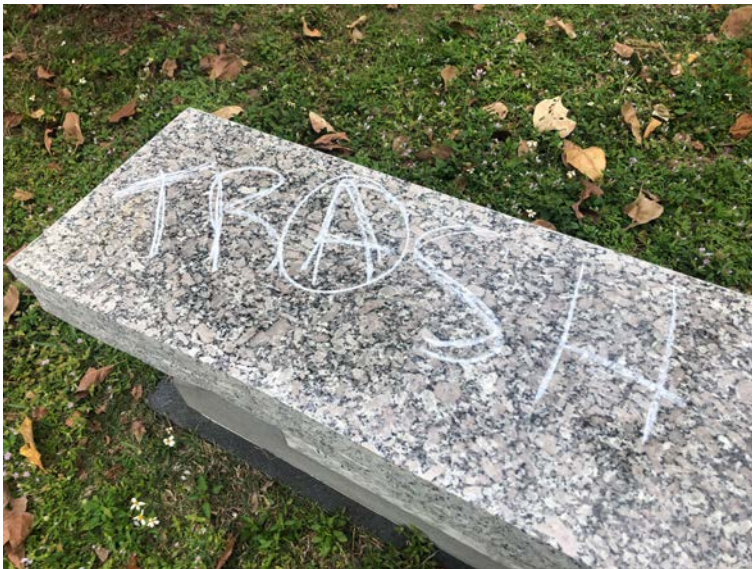
*Examples of vandalism on one of the monuments in the Confederate Circle. The cemetery grounds crew promptly acted in removing this graffiti. It is recommended that photographs be taken of such instances prior to treatment and after for documentation purposes.*

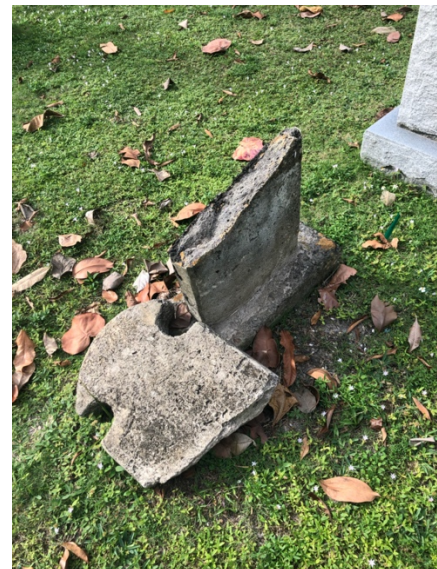
*Example of a marker in poor condition but high integrity that should be prioritized when determining an overall treatment approach at the cemetery.*

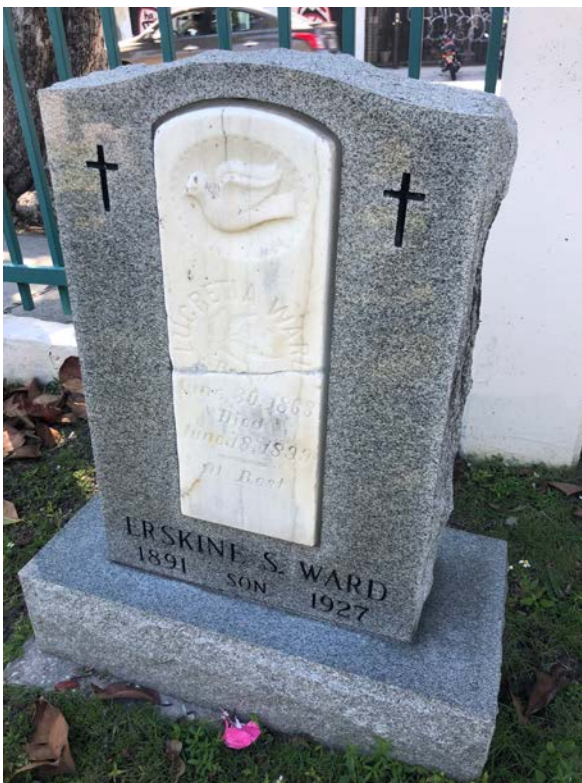
*19<sup>th</sup> century marble grave marker that was conserved by inserted into a modern granite marker. Found on the western boundary of the cemetery.*

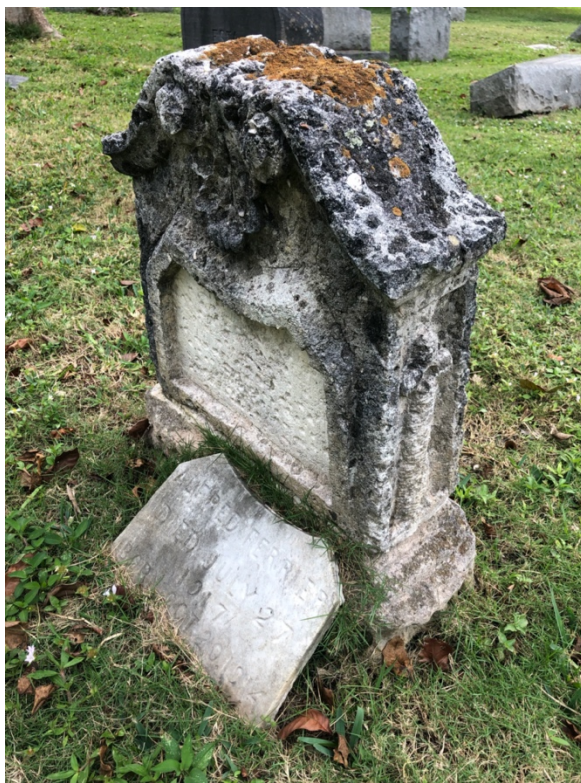
*One of the five (5) coral stone (oolitic limestone) markers with its detached marble plaque. This marker should be prioritized when determining overall cemetery treatment priorities due to the uniqueness of the material.*
